Diversified Metal Fabricators Service Bulletin SB 2052

Title	Locking Valve Leakage on Rear Railgear.
Document No.	SB-2052
Issue Date	10/08/2008 (SEW)
Units Affected	All rear railgear manufactured 1/2008 to 9/2008 with locking valves integral to the endcap of the rear hydraulic cylinders. (RW-1019, 1212, 1420, 1630, 1650)
Purpose	To address hydraulic fluid leakage from locking valves on rear cylinders.

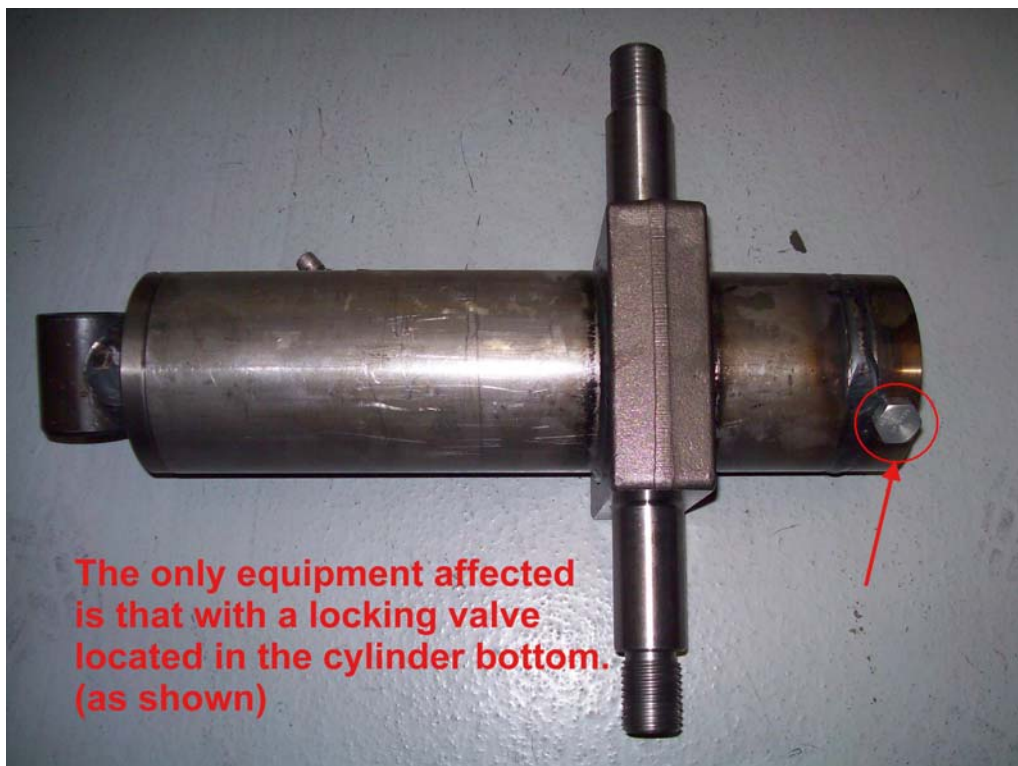
FIG A

The cylinders covered under this service bulletin will have a HYDRA FORCE brand locking valve cartridge that is installed in a cavity integral to the cylinder bottom as shown in FIG A.

Manufacturing inconsistencies of the cylinder end cap with integral locking valve cavity MAY prevent the HYDRA FORCE brand cartridge from fully seating. The resulting effect is that the cylinder could either:

- A) Leak hydraulic fluid from around the cartridge or
- B) Allow the railgear to drift from rail or stowed position if mechanical locking pins are not used.

Please note that the HYDRA FORCE cartridges in this equipment are not defective. They are simply slightly longer than the PARKER cartridges and may not work properly with the cavities as drilled during the subject time frame.

- 3) To replace the valves:
- Remove existing HYDRA FORCE locking valves
 - Inspect the cavity for any debris or other contamination.
 - Coat the new PARKER valves with hydraulic fluid paying particular attention to lubricate the seals well. (This is IMPORTANT!)
 - Start the new PARKER cartridges by hand, making as many turns as possible.
 - Tighten the cartridge to no greater than 15 FOOT POUNDS. Over torquing the valve can damage its internals and actually INCREASE likelihood of a leak.
 - Test railgear function and check for leaks.
- 4) If your railgear is covered under this service bulletin but is not currently experiencing any leakage or other problems, then please call DMF to determine if replacement is necessary.

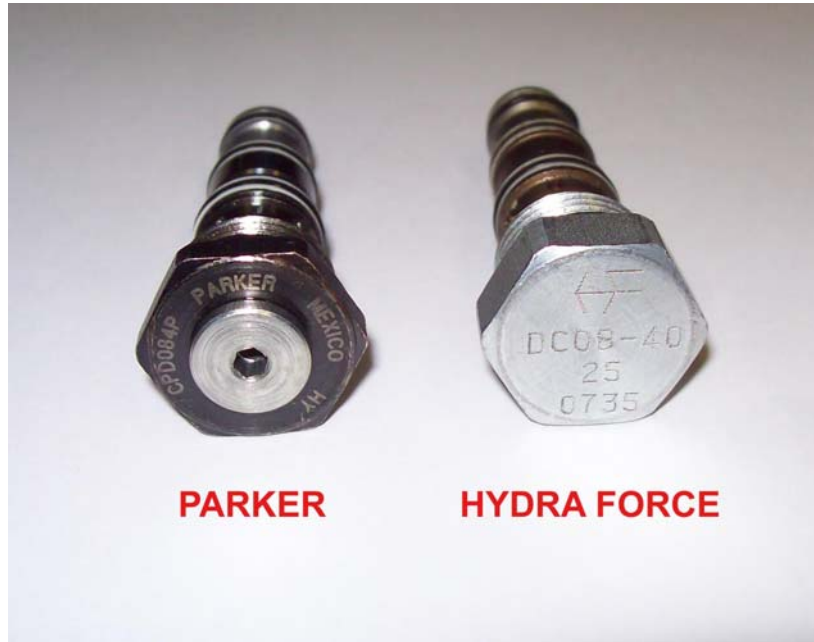
FIG B

DMF has used two brands of locking valve cartridges in its hydraulic cylinders, PARKER and HYDRA FORCE. The brand of locking valve cartridge can be determined using the above photograph. A PARKER cartridge will have a ½" diameter, 1/8" thick raised section in the middle of the head with a hexagonal shaped hole in the center. The HYDRA FORCE valve will be level across the whole head of the cartridge. NOTE: DMF paints all cylinders before they are shipped, so do not use color as a means of cartridge identification.
