Diversified Metal Fabricators Service Bulletin SB 2047:

Title	RW-1019 Washer Issue for 2005 and Newer Ford F-450/550's
Document No.	SB 2047
Issue Date	3/15/06 (WAK) Revised 4/24/06
Units Affected	Model year 2005 and newer Ford F-450s and F-550s
Purpose	This service bulletin addresses an installation error regarding RW-1019 front railgear on model year 2005 and newer Ford F-450's and F-550's.

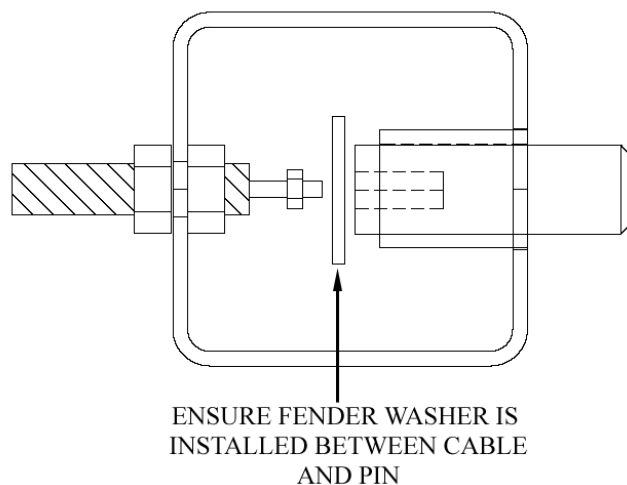
Identify Units with Missing Pin Off Fender Washers

The illustration below shows the cable operated pin off assembly for RW-1019 railgear which is standard on models for 2005 and newer Ford F-450/550s. There should be a fender washer installed between the remote cable operator and the actual pin itself. The washer prevents the pin from being over inserted into the guide tube. Over insertion can allow the pin to become cockeyed in the guide tube and snap the pin-off cable where it threads into the pin.

If there is no washer, a new one must be installed.

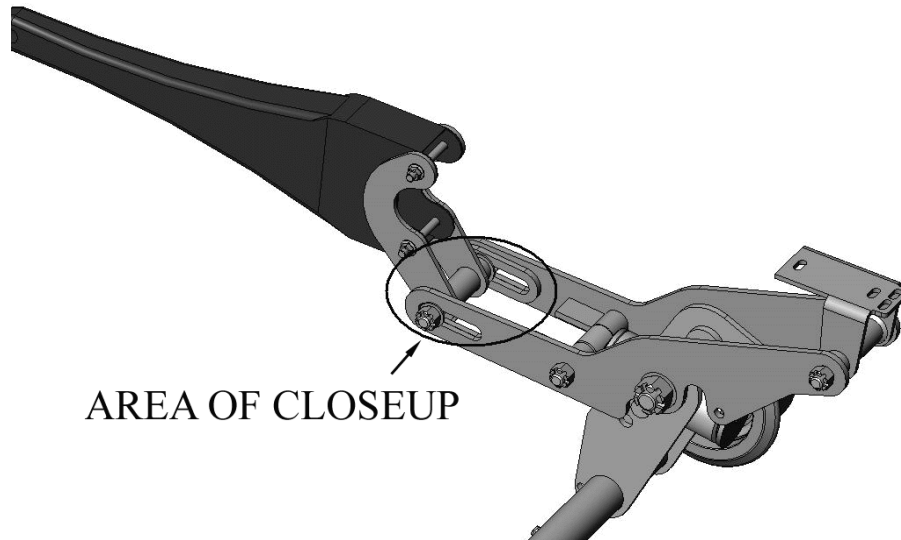
Identify Units with Missing Washers

The picture below shows the driver's side of a front set of RW-1019 railgear for a 2005 model year Ford F-450/550. For each side of the truck there are supposed to be 3 washers for the rear pin. There is supposed to be a 1-1/4" washer between each long arm and the spring bracket bolted to the radius arm. Additionally there should be a 1" washer between the inner long arm and the castellated nut.

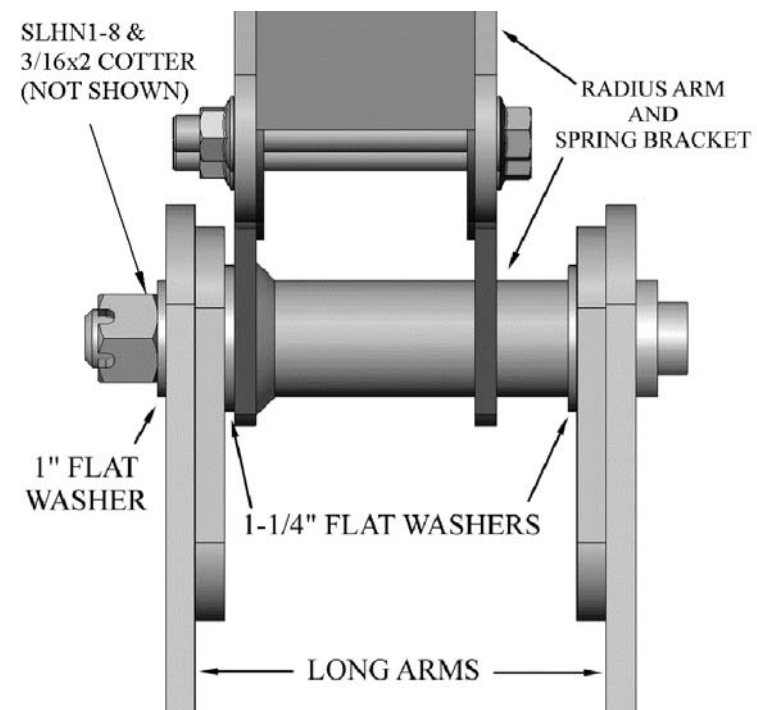
Please see the close-up diagram below for proper washer location.
