## Diversified Metal Fabricators Service Bulletin SB 2045

<b>Title</b>	RW-1013 Railwheel Bearing Hardware & Adjustment
<b>Document No.</b>	2045 rev A
<b>Issue Date</b>	7/22/05 <b>Revision C 7/19/10</b> (WAK )
<b>Units Affected</b>	All units with RW-1013 railgear – Supersedes SB-2042
<b>Purpose</b>	<ul style="list-style-type: none"><li>To call attention to a service issue with the bearing hardware used in RW-1013 railwheels.</li><li>To provide information and guidance to those involved in service and inspections.</li></ul>

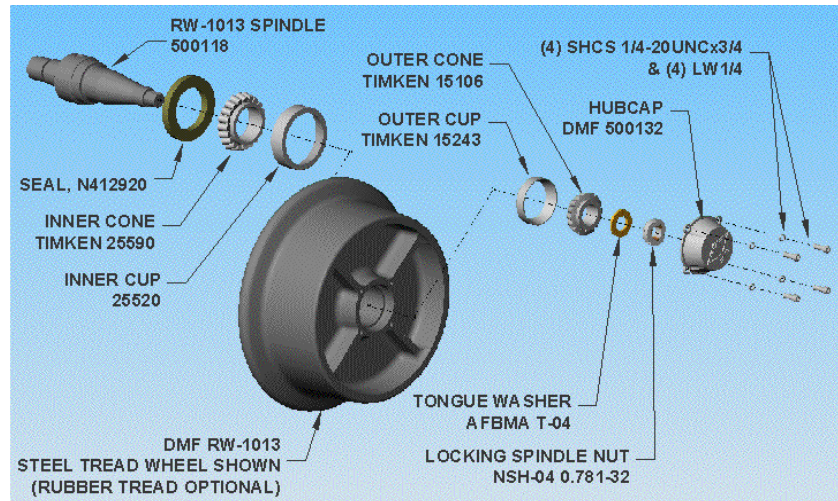
Exploded Assembly: RW-1013 Rail Wheel

There have been cases of RW-1013 railwheels becoming loose or coming off RW-1013 equipped vehicles. To address this, the revised spindle nut includes (3) brass shoes engaged by set screws to prevent these problems. The tab washer is no longer used, the tongue washer is still used. This Service Bulletin supersedes SB-2042.

The previous nut (N-04) has four flats and may have a brass tipped set screw. The new spindle nut (NSH-04) has three flats, three set screws and three brass shoes.

ALL RW-1013 UNITS MUST HAVE THE SPINDLE NUTS REPLACED WITH THE REVISED NUT.

1. Assemble components as shown in attached assembly drawing.
2. Tighten spindle nut to approximately 25-50 ft-lbs
3. Rotate wheel one full turn in each direction
4. Loosen spindle nut
5. Tighten spindle nut by hand while turning wheel until snug.
6. Back off spindle nut ¼ turn and ensure that the brass shoes are clear of the keyway. (1/4 turn should give the recommended 0.005" to 0.010" of endplay)
7. Tighten set screws progressively to 20-35 in-lbs. **Ensure that Allen Key is fully inserted to avoid rounding out socket set screw..**

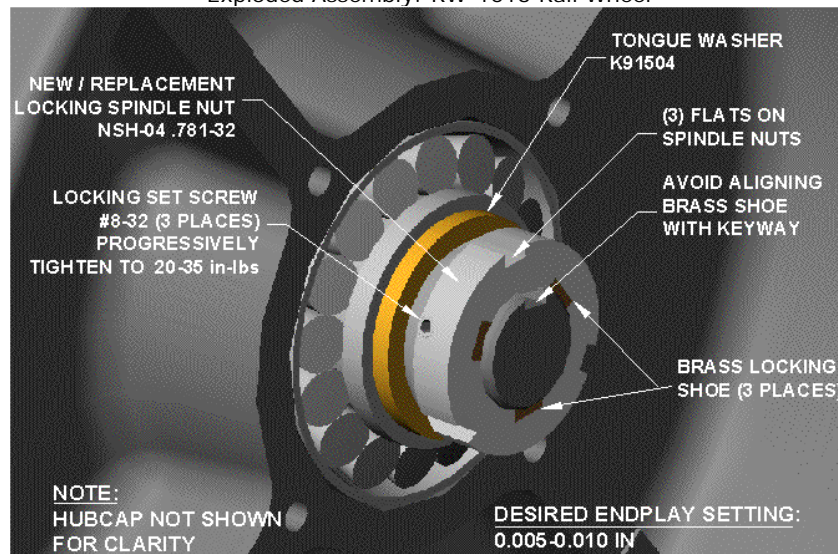
Bearing Hardware and Adjustment Details: RW-1013 Rail Wheel

- **The brass shoes must be loosened and "released" prior to disassembly! Failure to do so requires replacement of the NSH-04 nut.**
- **To release the shoes prior to disassembly, tap the nut at each (3) screw position after loosening the set screws.**

This procedure will reliably produce endplay in the desired range if it is frequently checked against an indicator measurement. DMF recommends that endplay be checked with a dial indicator.
