## Diversified Metal Fabricators Service Bulletin SB 2046

<b>Title</b>	Roto 180 Hitch Structure Reinforcement
<b>Document No.</b>	SB 2046
<b>Issue Date</b>	1/25/06 (WAK)
<b>Units Affected</b>	Roto-180 installed with Hitch Structure at DMF in 2005. All units should be checked and repaired as described below. Units must not tow until hitch has been inspected and repaired if necessary.
<b>Purpose</b>	To address an installation error in Pintle Hitch Structure.

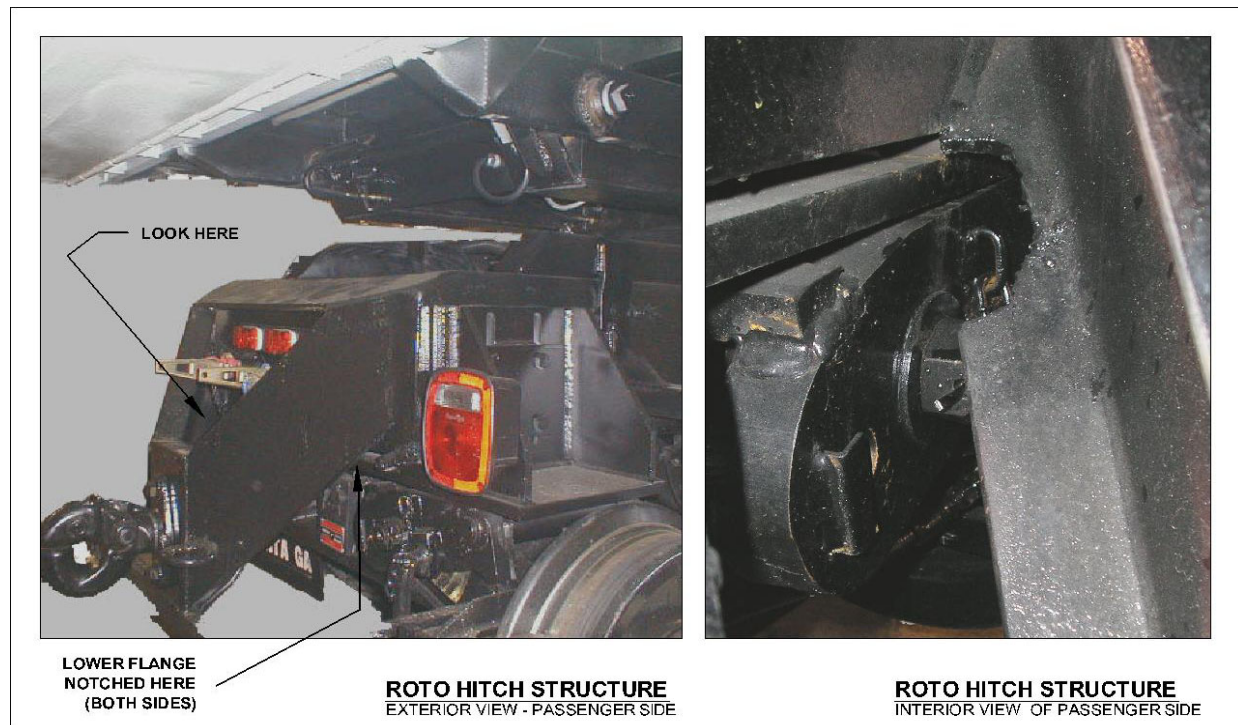
Notches were torch cut in the lower flanges of the main channel beams for clearance. These notches create a significant stress concentration and can cause a structural failure. Inspect units as shown below:
