## Service Bulletin SB 2047:

<b>Title</b>	RW-1019 Washer Issue for 2005 and Newer Ford F-450/550's
<b>Document No.</b>	SB 2047
<b>Issue Date</b>	3/15/06 (WAK) Revised 4/24/06
<b>Units Affected</b>	Model year 2005 and newer Ford F-450s and F-550s
<b>Purpose</b>	This service bulletin addresses an installation error regarding RW-1019 front railgear on model year 2005 and newer Ford F-450's and F-550's.

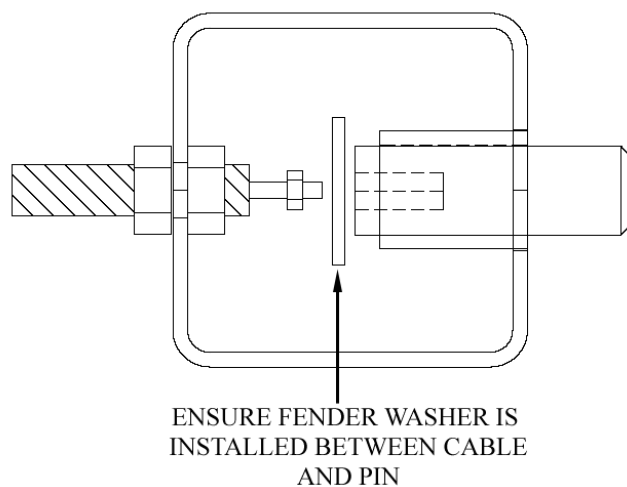
#### Identify Units with Missing Pin Off Fender Washers

The illustration below shows the cable operated pin off assembly for RW-1019 railgear which is standard on models for 2005 and newer Ford F-450/550s. There should be a fender washer installed between the remote cable operator and the actual pin itself. The washer prevents the pin from being over inserted into the guide tube. Over insertion can allow the pin to become cockeyed in the guide tube and snap the pin-off cable where it threads into the pin.

If there is no washer, a new one must be installed.

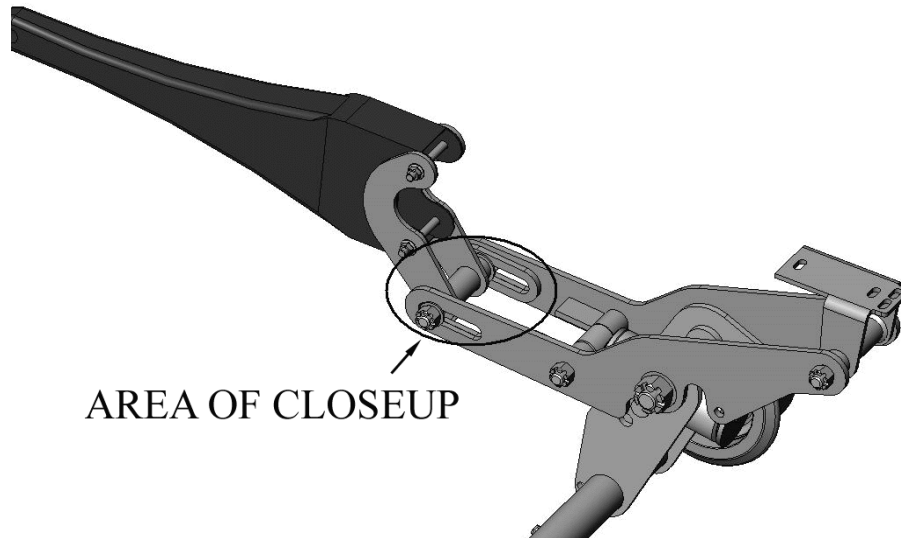
#### Identify Units with Missing Washers

The picture below shows the driver's side of a front set of RW-1019 railgear for a 2005 model year Ford F-450/550. For each side of the truck there are supposed to be 3 washers for the rear pin. There is supposed to be a 1-1/4" washer between each long arm and the spring bracket bolted to the radius arm. Additionally there should be a 1" washer between the inner long arm and the castellated nut.

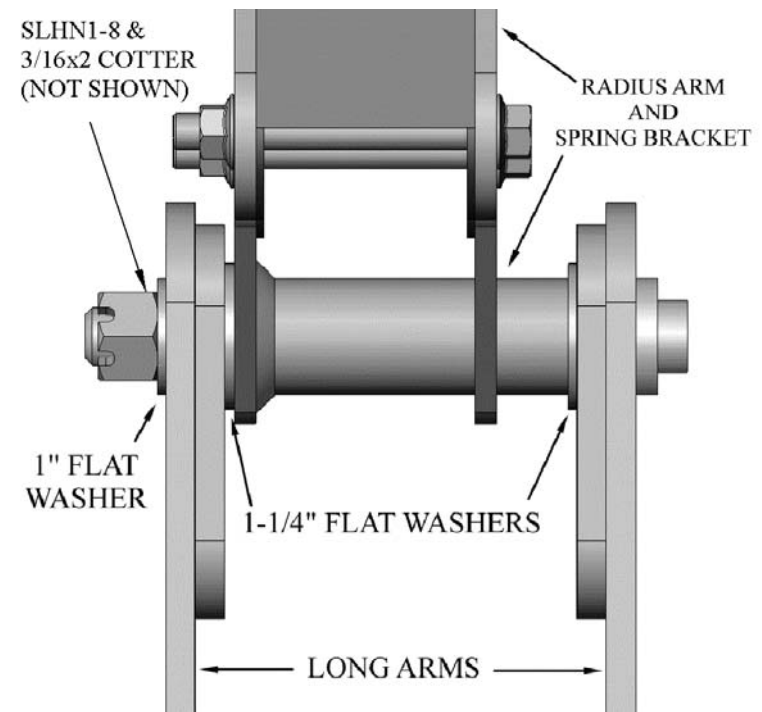
Please see the close-up diagram below for proper washer location.
