## Diversified Metal Fabricators Service Bulletin SB 2052

<b>Title</b>	Locking Valve Leakage on Rear Railgear.
<b>Document No.</b>	SB-2052
<b>Issue Date</b>	10/08/2008 (SEW )
<b>Units Affected</b>	All rear railgear manufactured 1/2008 to 9/2008 with locking valves integral to the endcap of the rear hydraulic cylinders. (RW-1019, 1212, 1420, 1630, 1650)
<b>Purpose</b>	To address hydraulic fluid leakage from locking valves on rear cylinders.

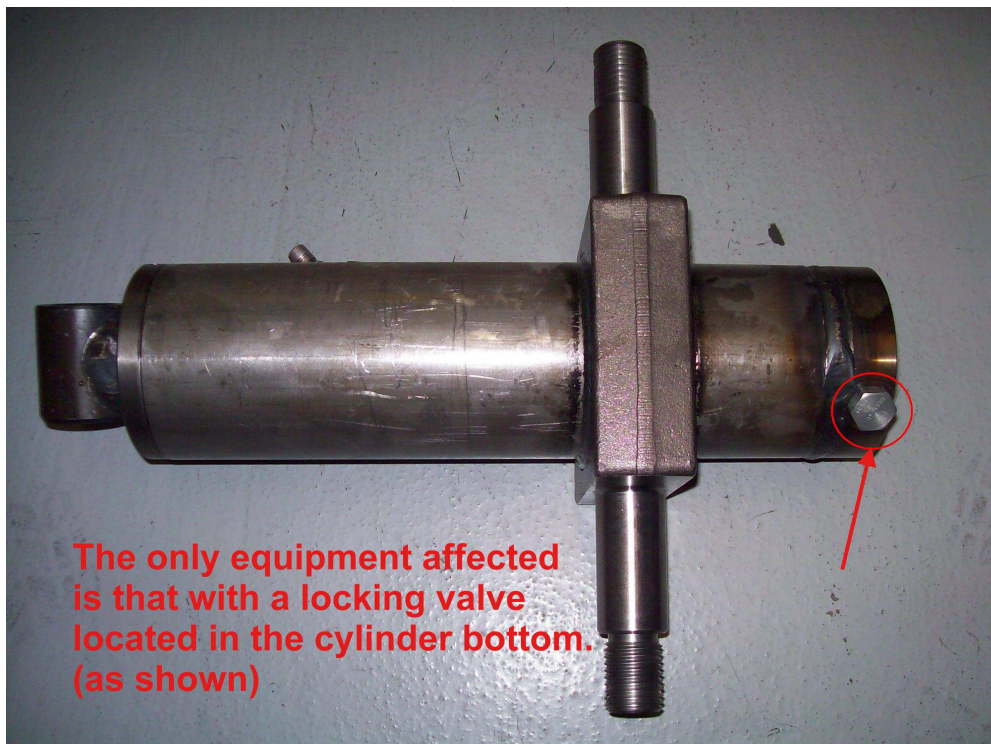
FIG A

The cylinders covered under this service bulletin will have a HYDRA FORCE brand locking valve cartridge that is installed in a cavity integral to the cylinder bottom as shown in FIG A.

Manufacturing inconsistencies of the cylinder end cap with integral locking valve cavity MAY prevent the HYDRA FORCE brand cartridge from fully seating. The resulting effect is that the cylinder could either:

- A) Leak hydraulic fluid from around the cartridge or
- B) Allow the railgear to drift from rail or stowed position if mechanical locking pins are not used.

- 3) To replace the valves:
- Remove existing HYDRA FORCE locking valves
  - Inspect the cavity for any debris or other contamination.
  - Coat the new PARKER valves with hydraulic fluid paying particular attention to lubricate the seals well. (This is IMPORTANT!)
  - Start the new PARKER cartridges by hand, making as many turns as possible.
  - Tighten the cartridge to no greater than 15 FOOT POUNDS. Over torquing the valve can damage its internals and actually INCREASE likelihood of a leak.
  - Test railgear function and check for leaks.
- 4) If your railgear is covered under this service bulletin but is not currently experiencing any leakage or other problems, then please call DMF to determine if replacement is necessary.

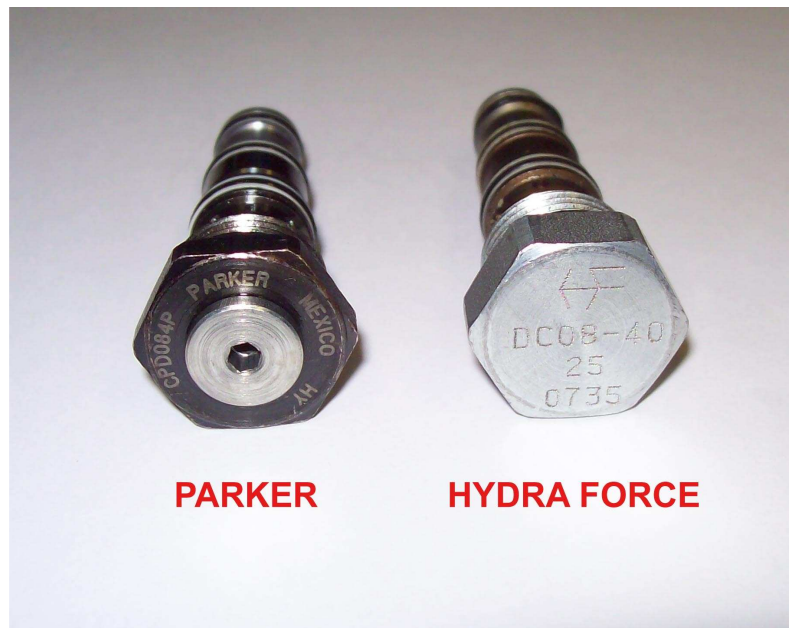
FIG B

DMF has used two brands of locking valve cartridges in its hydraulic cylinders, PARKER and HYDRA FORCE. The brand of locking valve cartridge can be determined using the above photograph. A PARKER cartridge will have a 1/2" diameter, 1/8" thick raised section in the middle of the head with a hexagonal shaped hole in the center. The HYDRA FORCE valve will be level across the whole head of the cartridge. NOTE: DMF paints all cylinders before they are shipped, so do not use color as a means of cartridge identification.
