## Diversified Metal Fabricators Service Bulletin SB 2078

<b>Title</b>	RW-1016 Suspension Arm Pin Hardware
<b>Document No.</b>	SB2078 Rev B
<b>Issue Date</b>	06/18/2020 (TAM)
<b>Release</b>	General
<b>Units Affected</b>	RW-1016 models (front and rear) with S/N's <u>lower than</u> 47000
<b>Purpose</b>	Reduced potential for suspension separation

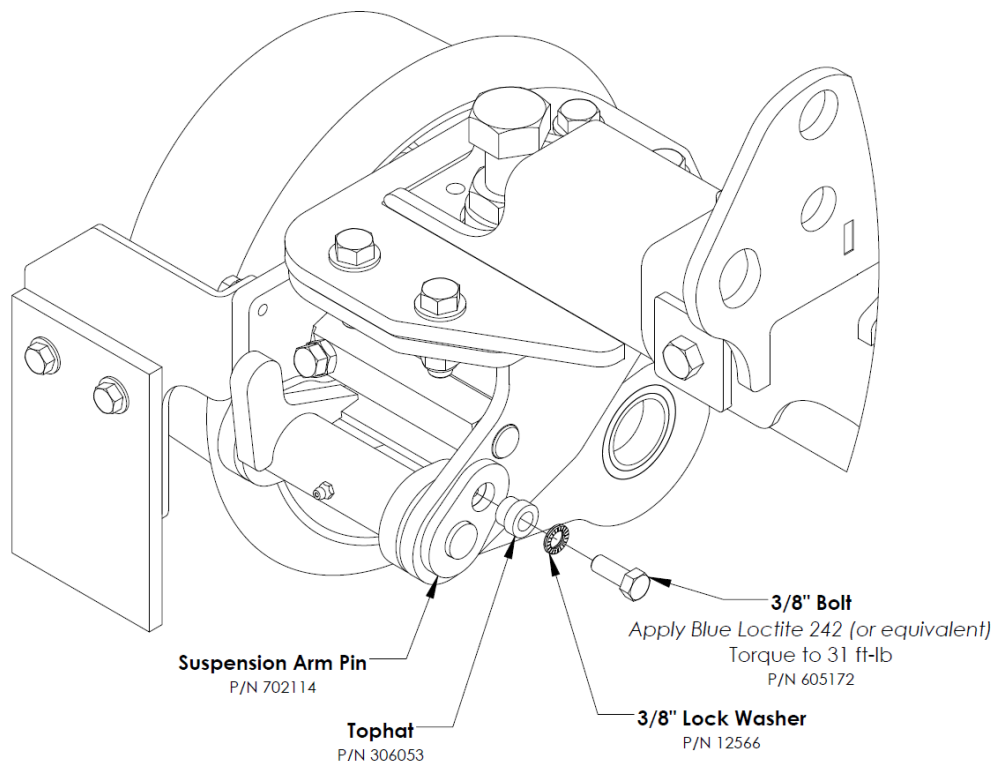
**Figure 1. RW-1016 Suspension Arm Pin Hardware**

In rare circumstances, the bolt retaining the suspension arm pin may loosen and fall out over time. This may allow the suspension pin to back out, and the lower suspension arm and wheel to separate from the railgear assembly. Customers are urged to inspect these pins and their retaining hardware, and apply a "blue" medium strength threadlocking compound to their retaining bolts.

1. Remove the 3/8" bolt retaining the suspension arm pin.
2. Apply a "blue" medium grade threadlocking compound to the 3/8" bolts (Loctite 242 or equivalent).
3. Reinstall 3/8" bolts, tophats, and lockwashers and torque to 31 ft-lb.
4. Repeat procedure on all RW-1016 suspension assemblies on vehicle.
