Diversified Metal Fabricators Service Bulletin SB 2078

Title	RW-1016 Suspension Arm Lock Washer Replacement
Document No.	SB2078 Rev A
Issue Date	11/14/2019 (TAM)
Release	General
Units Affected	RW-1016 models (front and rear) with S/N's <u>lower than</u> 46032
Purpose	Reduced potential for suspension separation

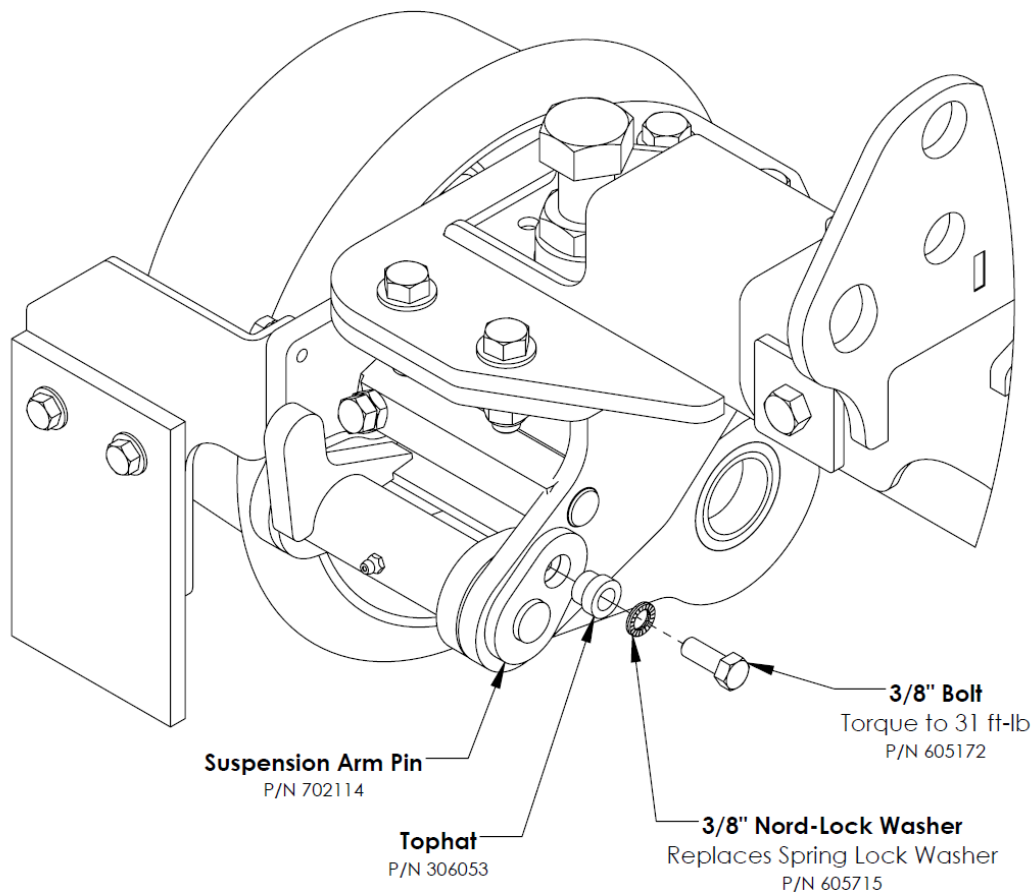
In rare circumstances, the bolt retaining the suspension arm pin may loosen and fall out over time. This may allow the suspension pin to back out, and the lower suspension arm and wheel to separate from the railgear assembly. Replacing the standard spring lock washers under the retaining bolt with upgraded Nord-Lock washers will greatly increase the vibration resistance of retaining bolt.

Figure 1. RW-1016 Suspension Arm Lock Washer Replacement

1. Contact DMF and request QUANTITY 4 of P/N 605715 (NORD-LOCK WASHER, 3/8").
2. Remove the 3/8" bolt retaining the suspension arm pin.
3. Remove and discard the 3/8" spring lock washer.
4. Make sure the "top hat" is reinstalled against the pin head.
5. Reinstall 3/8" bolt using a 3/8" Nord-Lock washer. Nord-Lock washers are a two-piece design, but are held together with adhesive for ease of assembly. Do not separate the washer pairs.
6. Torque 3/8" bolt to 31 ft-lb.
7. Repeat procedure on all RW-1016 suspension assemblies on vehicle.
