Diversified Metal Fabricators Service Bulletin SB 2079

Title	RW-1019B Front Pin Lock Washer Replacement
Document No.	SB2079 Rev #
Issue Date	11/11/2019 (TAM)
Release	General
Units Affected	RW-1019B models (front only) with ship dates prior to 11/8/19 (~SN 45680)
Purpose	Reduced potential for front pin separation

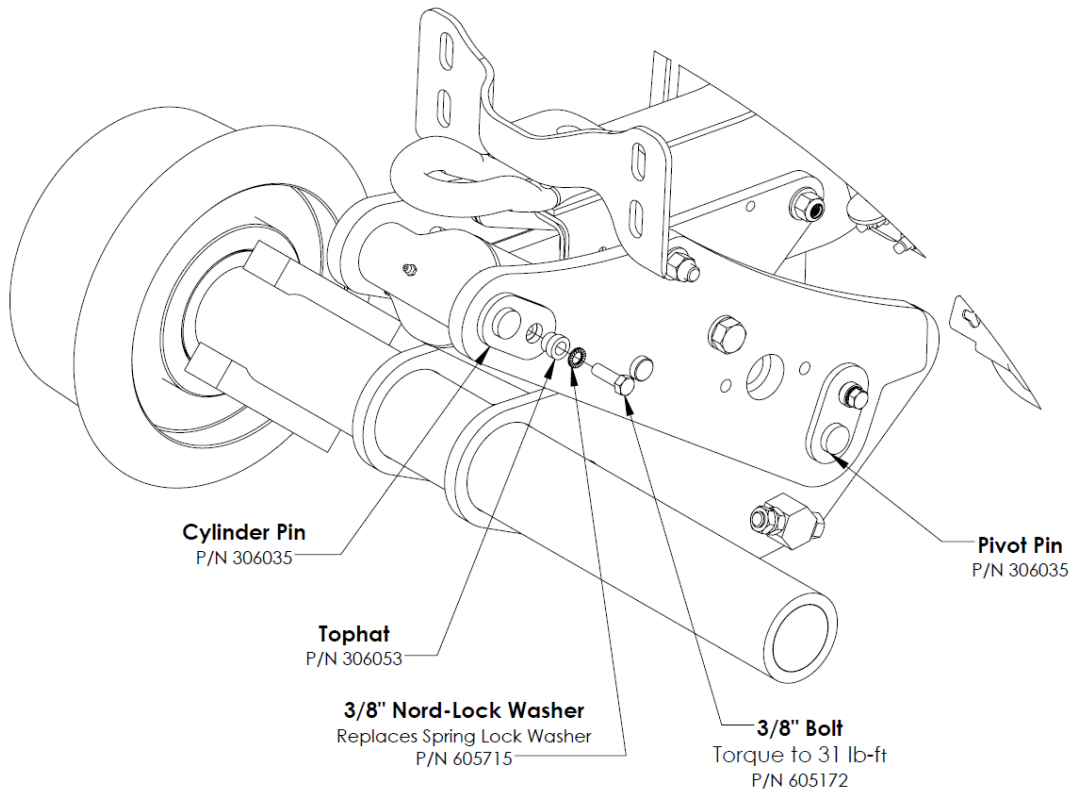
Figure 1. RW-1019B Front Pin Lock Washer Replacement – Ford & Ram

Under sustained vibration, the bolts retaining some pins in front RW-1019B assemblies may loosen and fall out over time. This could allow the pins to back out, causing key railgear components to separate. While DMF is unaware of any reported failures of this type occurring in the field, customers are urged to inspect these pins and replace the lock washers as a preventative measure. Replacing the standard spring lock washers under the retaining bolt with upgraded Nord-Lock washers provided by DMF will greatly increase the vibration resistance of the retaining bolt.

1. Contact DMF and request QUANTITY 4 of P/N 605715 (NORD-LOCK WASHER, 3/8").
2. Remove the 3/8" bolts retaining the cylinder pin and the pivot pin (**FIGURE 1**; Ford shown, Ram similar).
3. Remove and discard the 3/8" spring lock washers.
4. Make sure the "top hats" are reinstalled against the pin head.
5. Reinstall 3/8" bolts using 3/8" Nord-Lock washers. Nord-Lock washers are a two-piece design, but are held together with adhesive for ease of assembly. Do not separate the washer pairs.
6. Torque 3/8" bolts to 31 ft-lb.
7. Repeat procedure on remaining pins on opposite side of the vehicle.
8. The shorter pin through the rod end of the cylinder is secured with a nylock nut and does not require a Nord-Lock washer.
