Diversified Metal Fabricators Service Bulletin SB 2079

Title	RW-1019B Front Pin Hardware
Document No.	SB2079 Rev A
Issue Date	06/18/2020 (TAM)
Release	General
Units Affected	RW-1019B models (front only) with ship dates prior to 06/17/20 (~SN 47000)
Purpose	Reduced potential for front pin separation

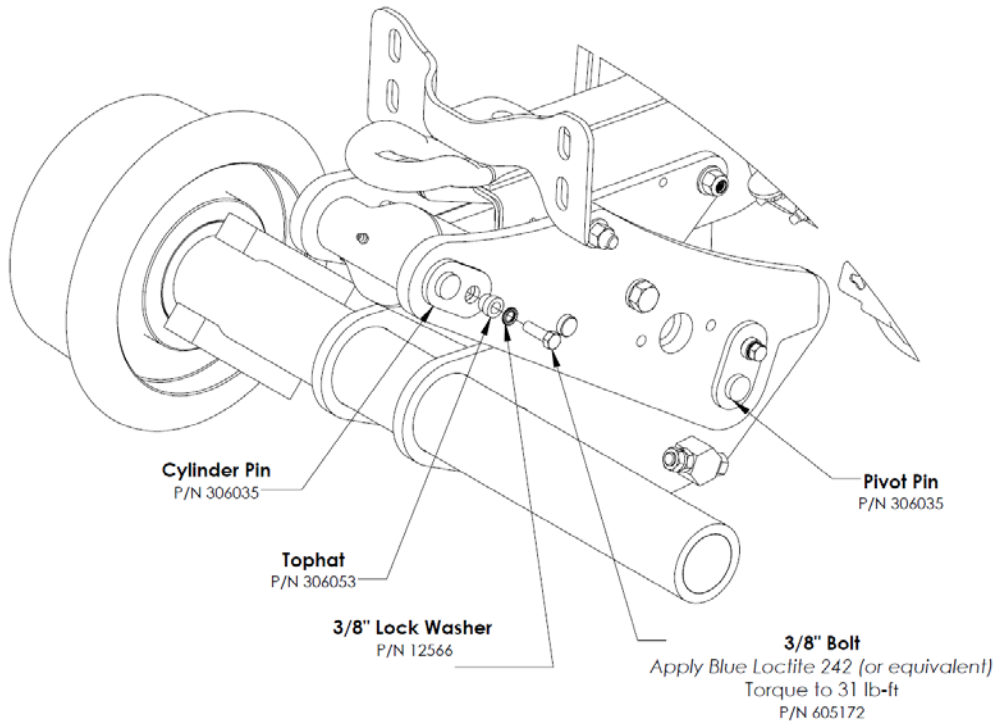
Figure 1. RW-1019B Front Pin Assembly – Ford & Ram

Under sustained vibration, the bolts retaining some pins in front RW-1019B assemblies may loosen and fall out over time. This could allow the pins to back out, causing key railgear components to separate. While DMF is unaware of any reported failures of this type occurring in the field, customers are urged to inspect these pins and apply a "blue" medium strength threadlocking compound to their retaining bolts.

1. Remove the 3/8" bolts retaining the base-end cylinder pin and the pivot pin (**FIGURE 1**; Ford shown, Ram similar).
2. Apply a "blue" medium grade threadlocking compound to the 3/8" bolts (Loctite 242 or equivalent).
3. Reinstall 3/8" bolts, tophats, and lock washers and torque to 31 ft-lb.
4. Repeat procedure on remaining pins on opposite side of the vehicle.
5. The shorter pin through the rod end of the cylinder is secured with a nylock nut and does not require threadlocking compound.
