Diversified Metal Fabricators Service Bulletin SB 2045

Title	RW-1013 Railwheel Bearing Hardware & Adjustment
Document No.	2045
Issue Date	7/22/05 (WAK)
Units Affected	All units with RW-1013 railgear – Supercedes SB-2042
Purpose	<ul style="list-style-type: none">• To call attention to a service issue with the bearing hardware used in RW-1013 railwheels.• To provide information and guidance to those involved in service and inspections.

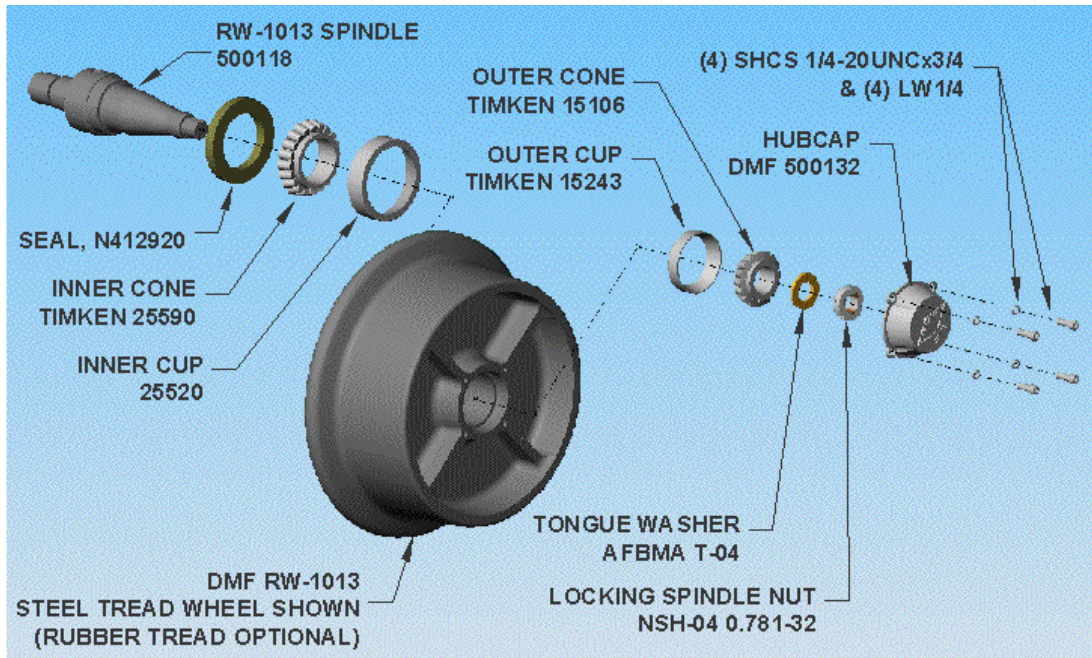
Exploded Assembly: RW-1013 Rail Wheel

There have been cases of RW-1013 railwheels becoming loose or coming off RW-1013 equipped vehicles. To address this, the revised spindle nut includes (3) brass shoes engaged by set screws to prevent these problems. The tab washer is no longer used, the tongue washer is still used. This Service Bulletin supercedes SB-2042.

The previous nut (N-04) has four flats and may have a brass tipped set screw. The new spindle nut (NSH-04) has three flats, three set screws and three brass shoes.

ALL RW-1013 UNITS MUST HAVE THE SPINDLE NUTS REPLACED WITH THE REVISED NUT.

1. Assemble components as shown in attached assembly drawing.
2. Tighten spindle nut to approximately 25-50 ft-lbs
3. Rotate wheel one full turn in each direction
4. Loosen spindle nut
5. Tighten spindle nut by hand while turning wheel until snug.
6. Back off spindle nut ¼ turn and ensure that the brass shoes are clear of the keyway. (1/4 turn should give the recommended 0.005" to 0.010" of endplay)
7. Tighten set screws progressively to 20-35 in-lbs.
